EFFECT OF FIBRE REINFORCED POLYMER WRAPPING ON MECHANICAL PROPERTIES OF CONCRETE SUBJECTED TO FIRE

Abstract.

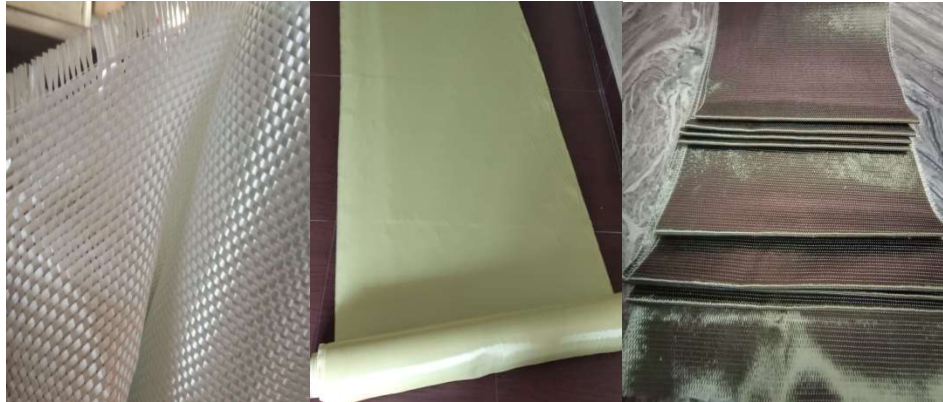
Fig. 1 - FRP laminates (a) GFRP; (b) AFRP; (c) BFRP

Unidirectional FRP laminates accustomed to retrofit the thermally damaged specimens. Table 3 lists the features of the FRPs utilized in this investigation. Figure 1 depicts the different FRPs used such as GFRP, BFRP, and AFRP one-to-one.

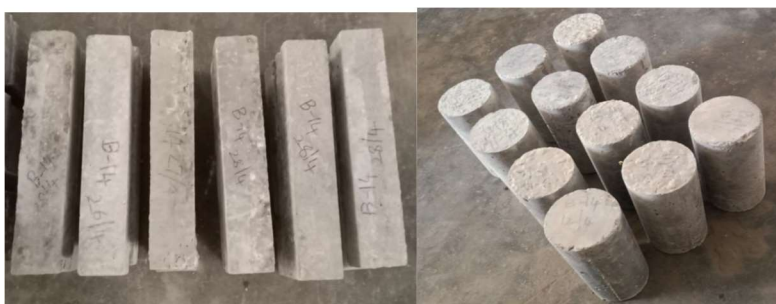
Fig. 2 – Concrete specimens after curing

temperatures of 250°C, 500°C and 750°C. After that, the specimen were air cooled before being placed to the examination. Figure 2 shows concrete specimens after curing.

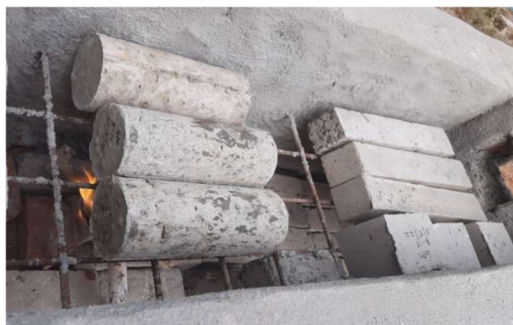
Fig. 3 – Fire exposure on concrete specimens

All reseaches were done in furnace made of refractory bricks that met ISO 834 standard[15]. A high-speed burner was assigned to burn cylindrical specimens as exposed in figure 3. The degree range was monitored using a K-type thermocouple (as shown in figure 4) and a temperature control device (UTC4202 model) to maintain the fire temperature. After being showing to fire for various periods of time (1h, 2h, and 3h), the heat range was observed before the cylindrical specimens were permitted to cool inside the furnace.

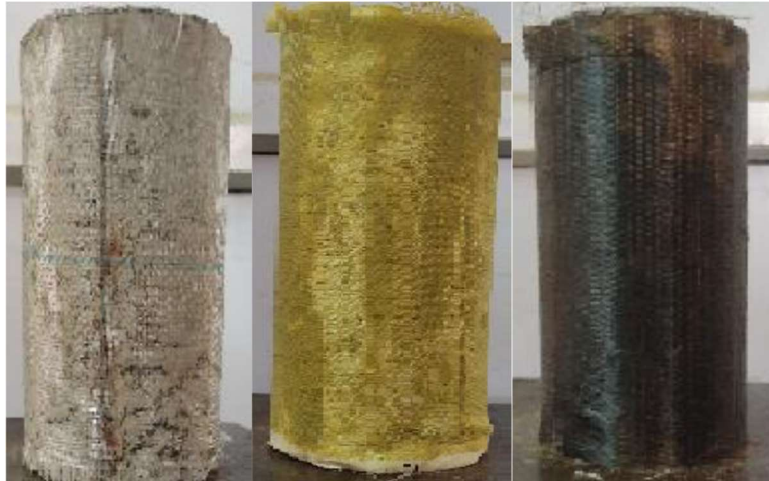
Fig. 5 – FRP wrapped specimens

The FRP laminates were bonded in accordance with the ISIS manual and ACI440-2R guidelines. The FRP laminates were wrapped around the specimens in a direction perpendicular to the load application [14]. The air-cooled specimens were removed from the furnace and roughened on all sides before being wrapped. The required amount of epoxy and hardener were mixed and applied uniformly around the cylinder. The FRP has adhered to the specimen using rollers to prevent air pockets. Allowed up to 48 hours for the adhesive to dry. Once they had dried, the required tests were performed. The specimens with fire damage are encased in FRP laminates in Figure 5.

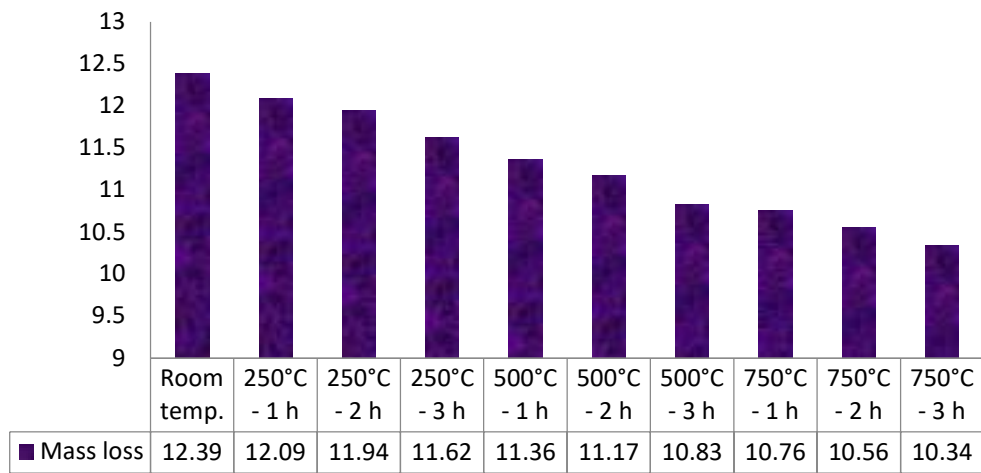
Fig. 7 – Mass of concrete prism exposed to different temperatures and durations.

Figure 6 and 7 shows the outcomes of the weight loss in concrete specimens after being reveal to the fire of different degrees and time. The result illustrates that the initial mass loss was brought on by evaporation and the decrease of free water. The weight loss of the specimen when it was disclosed to fire at different degrees (250°C, 500°C, and 750°C) for an hour was approximately 2.45%, 8.43%, and 13.16%. 3.61%, 9.86%, and 14.85%, respectively, were determined to the mass losses for specimen subjected to fire for two hours at temperatures of 250°C, 500°C, and 750°C. The weight reduction during three hours of sample exposure to fire at various temperatures (250°C, 500°C, and 750°C) was reported to be 6.18%, 12.66%, and 16.46%. The dryness of hydrated chemical components in concrete was the cause of the reduction in the mass of sample at elevated temperatures.

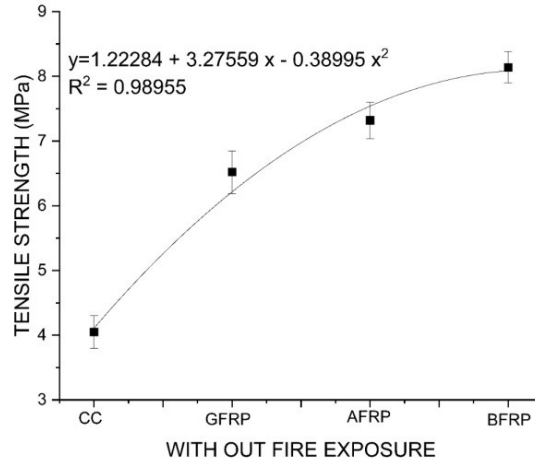
Fig. 8 – Tensile strength of concrete without fire exposure strengthened with FRPs

Figure 8 shows the split tensile property of concrete at normal degree for both unwrapped and wrapped specimens. From the trial outcomes, it is evident that the specimens wrapped with GFRP, AFRP and BFRP showed improved strength of about 60.98%, 80.74% and 100.98% respectively. The improvement in resilience of FRP strengthened specimen was because of the fibre’s tensile strength. The bonding of the FRP wrap to the concrete’s surface has an impact on the strength of FRP-enhanced concrete as well.

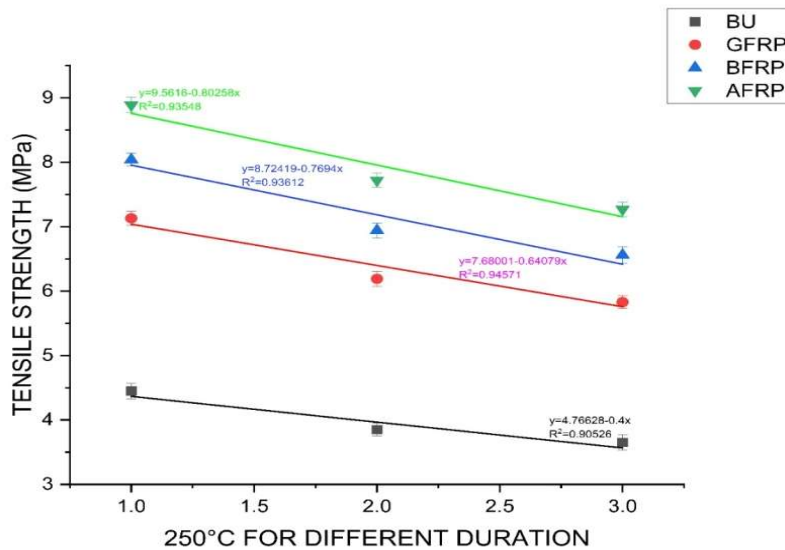
Fig. 9 – Tensile strength of concrete exposed to 250°C unwrapped and wrapped with different FRPs

The ductile property of fire exposed specimens to different temperature and duration was plotted in figure 9 – 11. It also provides the tensile strength of specimen that has been retrofitted with various FRPs after being damaged by fire. When the concrete is subjected to 250°C for 1 hour, the tensile strength of the specimen increased by 9.87%. The escalation in strength was due to the dryness of pore water. Further, the tensile strength cylinder decreases by 5.19% and 10.95% after 2 hours and 3 hours of revelation to heat at 250°C. The reduction in strength was due to the difference in thermal development of cement glue and aggregate. Further, by retrofitting the fire damaged specimens with GFRP, AFRP and BFRP the tensile property increased by 60.23%, 80.21% and 99.81% respectively. The improvement in the tensile property because of fibre's tensile modulus. among the three fibres, the basalt fibre laminate outperformed the other two fibre laminates used in this investigation, because of its high tensile strength than GFRP and AFRP laminates.

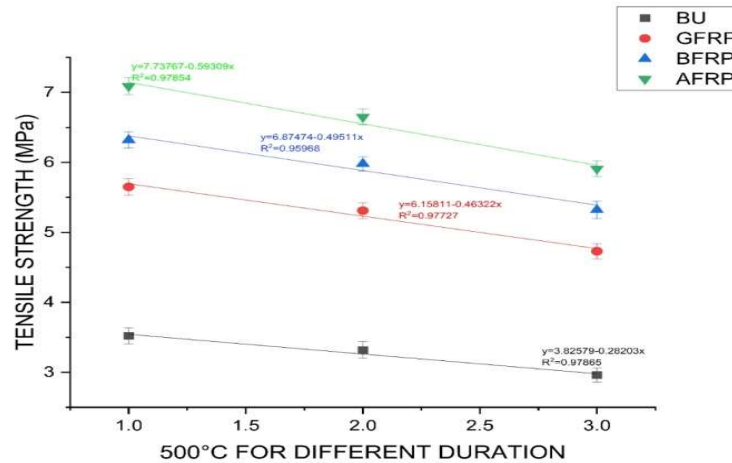
Fig. 10 – Tensile strength of concrete exposed to 500°C unwrapped and wrapped with different FRPs

When the specimen is subjected to 500°C for 1 hour, 2 hours and 3 hours, the loss in strength of the specimens was witnessed to be 15.05%, 21.98% and 36.82% which confirms the results reported previously (Kodur 2014)[17]. Similar observations were reported previously (Kodur et al. 2019)[2]. The alterations among the thermal enlargement rates of cement glue and aggregate were responsible for the loss in concrete's tensile strength. Wrapping of fire spoiled specimens with FRP increases the tensile property of the cylinder. After being retrofitted with GFRP, AFRP, and BFRP, the percentage surge in the tensile property of the fire-damaged cylinder was 60.07%, 79.79%, and 100.46%, respectively.

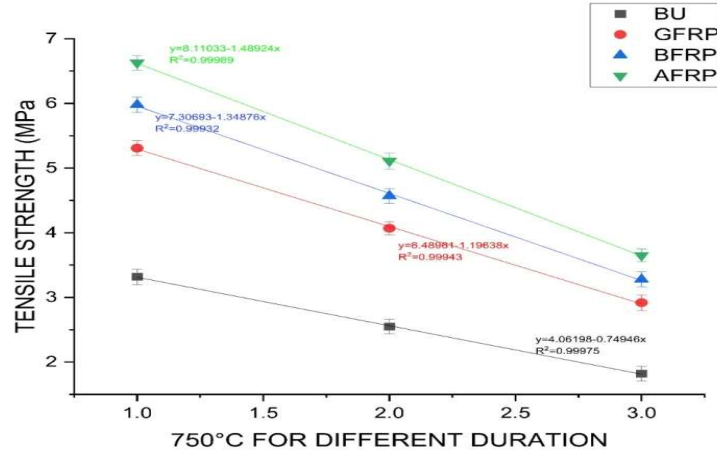
Fig. 11 – Tensile strength of concrete exposed to 750°C unwrapped and wrapped with different FRPs

The toughness of the specimens was detected to drop by 22.35%, 58.82%, and 122.52% when the specimen was showing to 750°C for 1, 2, and 3 hours, respectively. Moreover, the tensile property of the fire-damaged cylinders was enhanced by 59.98%, 79.84%, and 100.20%, respectively, by retrofitting the fire damaged cylinders with GFRP, AFRP, and BFRP.

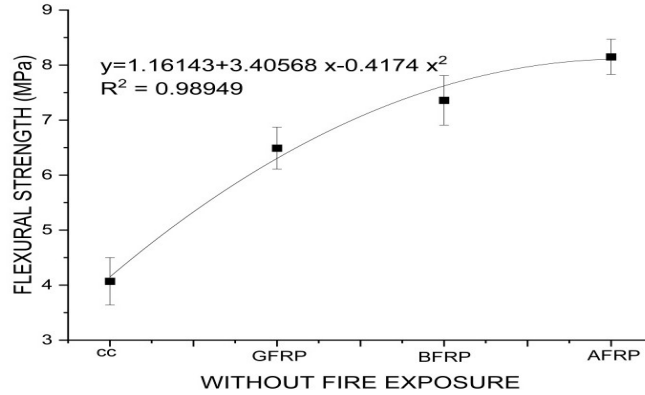
Fig. 12 – Flexural strength of concrete without fire exposure strengthened with FRPs

Flexural behaviour of specimen at normal temperature for specimens wrapped in FRP and for specimens not wrapped in FRP was plotted in figure 12. The test findings clearly reveal that concrete specimens wrapped with GFRP, AFRP, and BFRP had enhanced strengths of about 60.98%, 80.74%, and 100.98%, respectively.

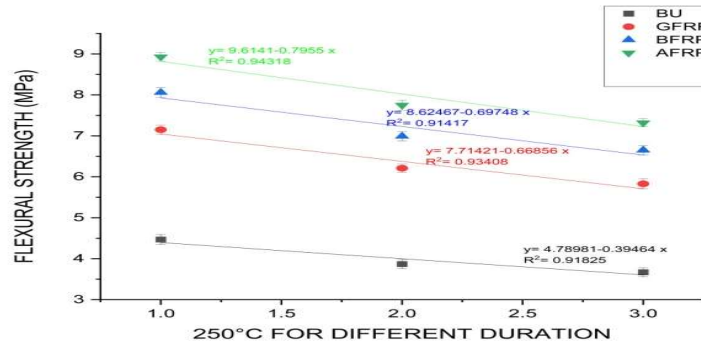
Fig. 13 – Flexural strength of concrete exposed to 250°C unwrapped and wrapped with different FRPs

The flexural property of specimens showing to fire at different degrees and for varying lengths of time was plotted in figure 13 – 15. Additionally, it gives the flexural strength of fire-harm concrete that has been retrofitted with different FRPs. From this study, it is evident that as the fire degree amplifying the flexural strength decreases. The amount of damage depends on temperature, exposure time, nature of aggregate used etc. Similar observations as that of tensile strength were attained for flexural strengths of the specimens after disclosure to diverse temperatures and for different durations.

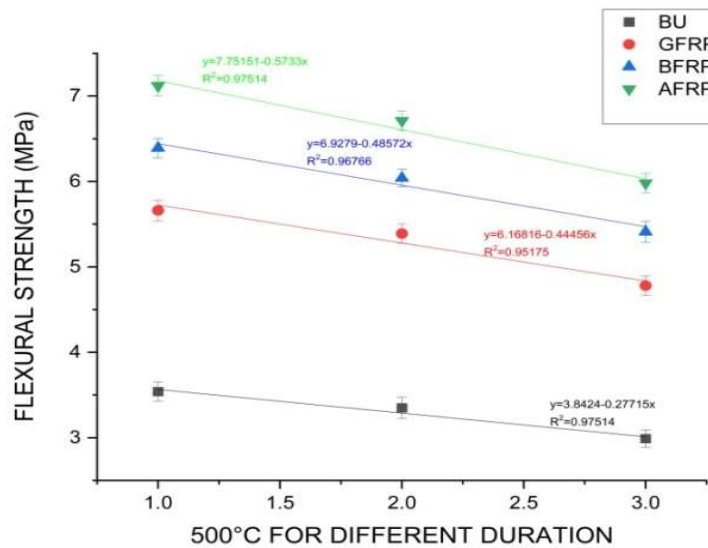
Fig. 14 – Flexural strength of concrete exposed to 500°C unwrapped and wrapped with different FRPs

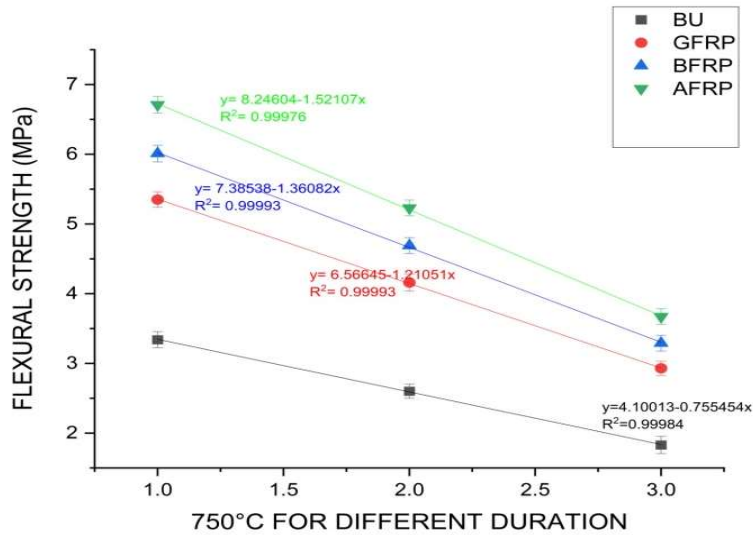
Fig. 15 – Flexural strength of concrete exposed to 750°C unwrapped and wrapped with different FRPs

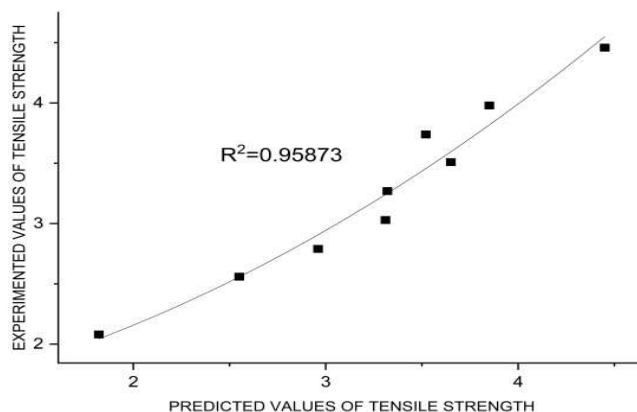
Fig. 17 - Scatter Plot for Tensile Strength.

A scatter plot was plotted against experimented values and observed values of tensile strength, flexural strength and Young's modulus. The observed tensile strength, flexural strength and Young's modulus values were compared with their corresponding predicted values which gives an R^2 value of 0.95466, 0.9 and 0.9 respectively as shown in figure 17, 18 and 19.

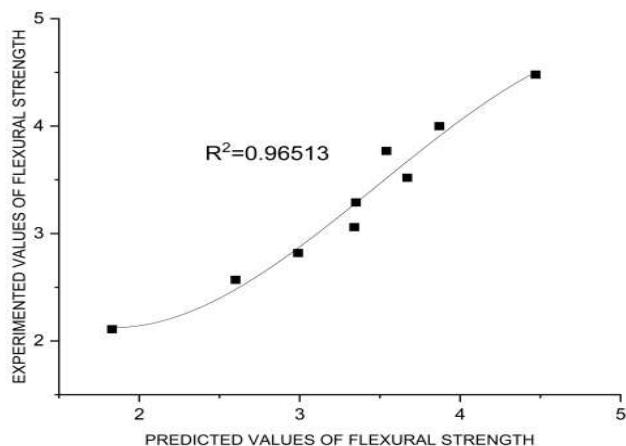
Fig. 18 - Scatter Plot for Flexural Strength.

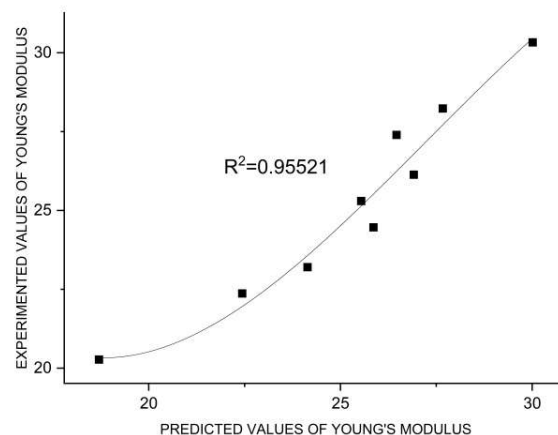
Fig. 19 - Scatter Plot for Young's modulus.
